⑨ **BUREAU OF SHIPS GROUP**  
**TECHNICAL INSPECTION REPORT.**

⑥ **OPERATION CROSSROADS.**  
**U.S.S. RHIND (DD 404)**  
**TEST ABLE [U].** ⑧

**OPERATION CROSSROADS** **CONFIDENTIAL**  
Security Information

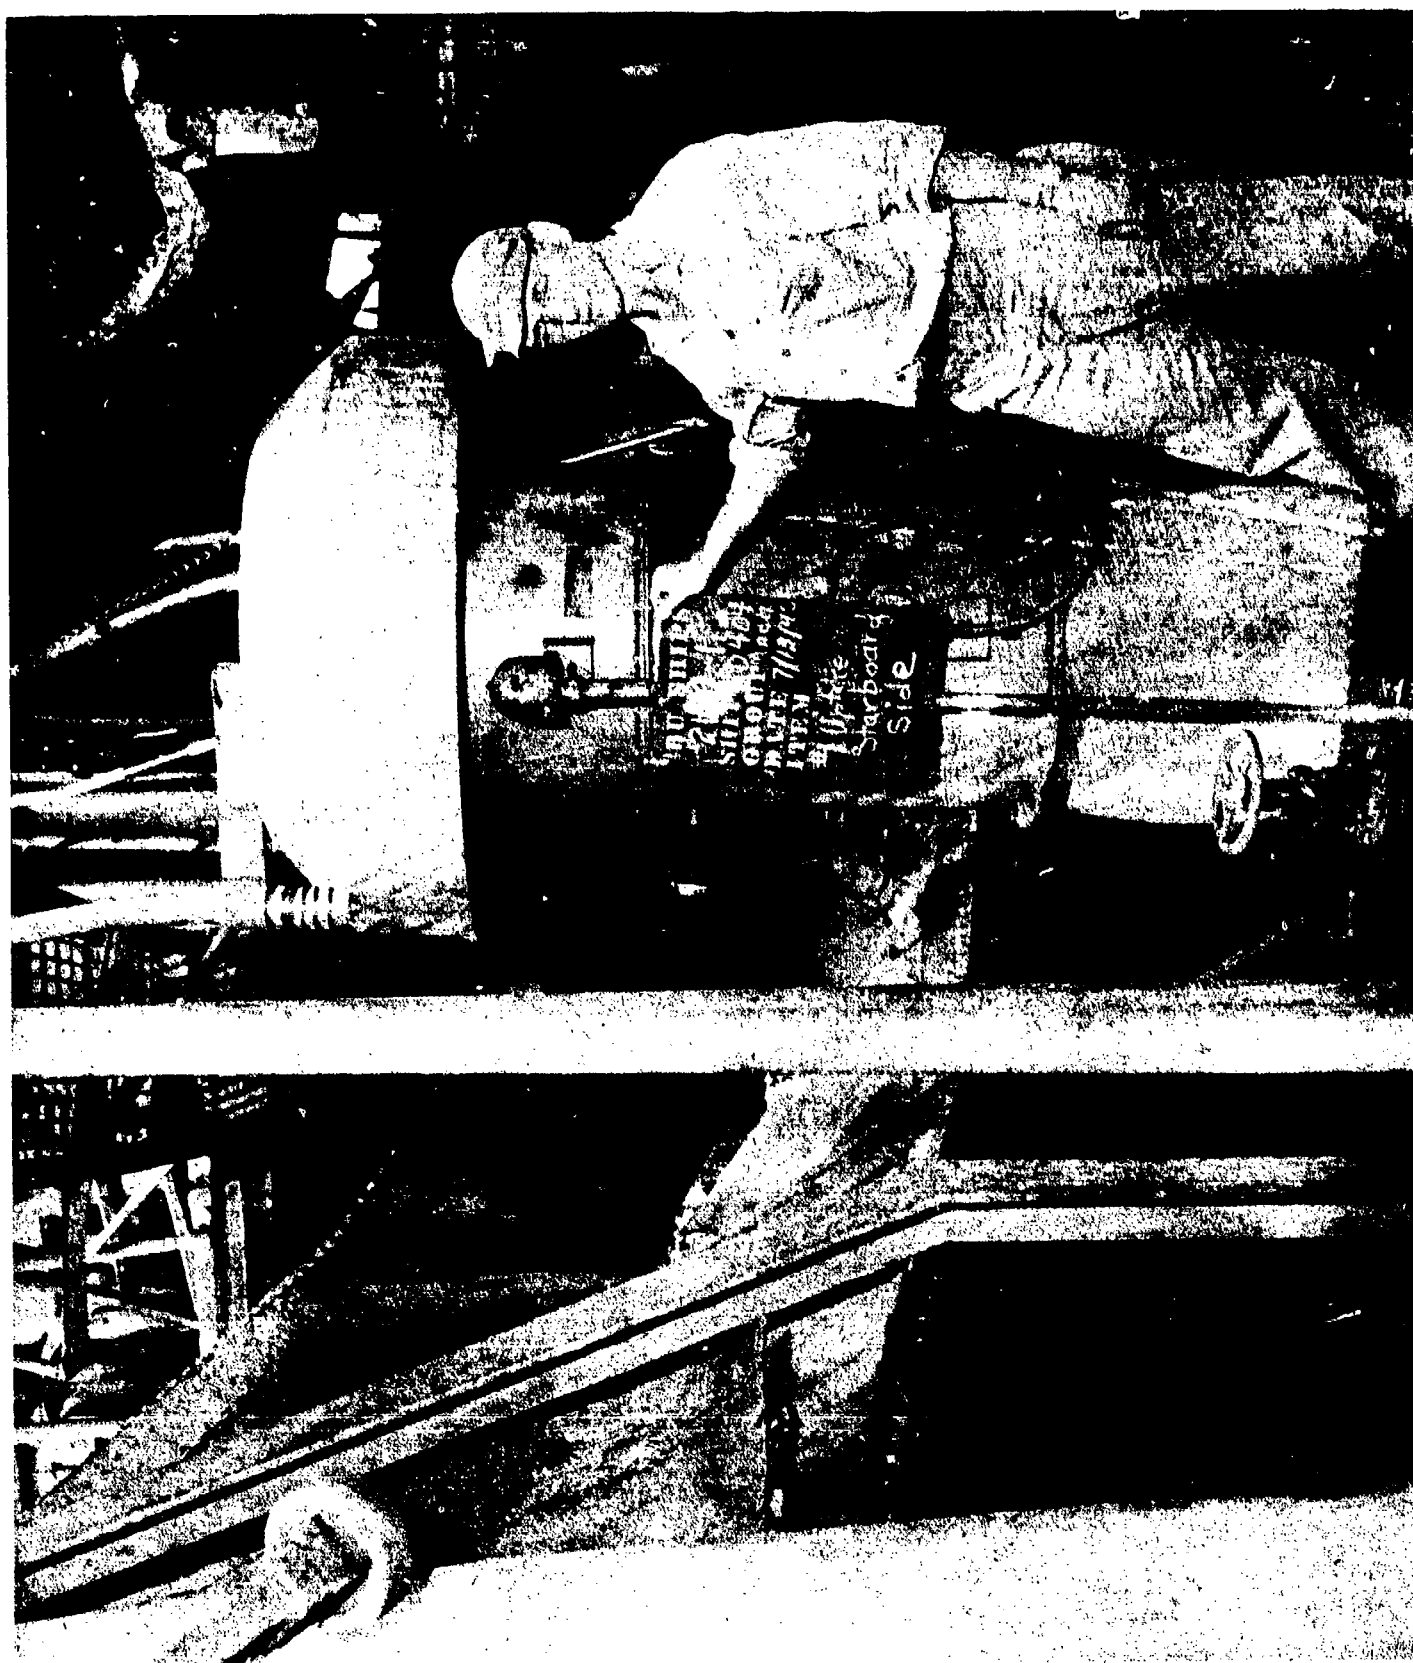
AA-CR-62-2170-1. No. 1 uptake, starboard side.

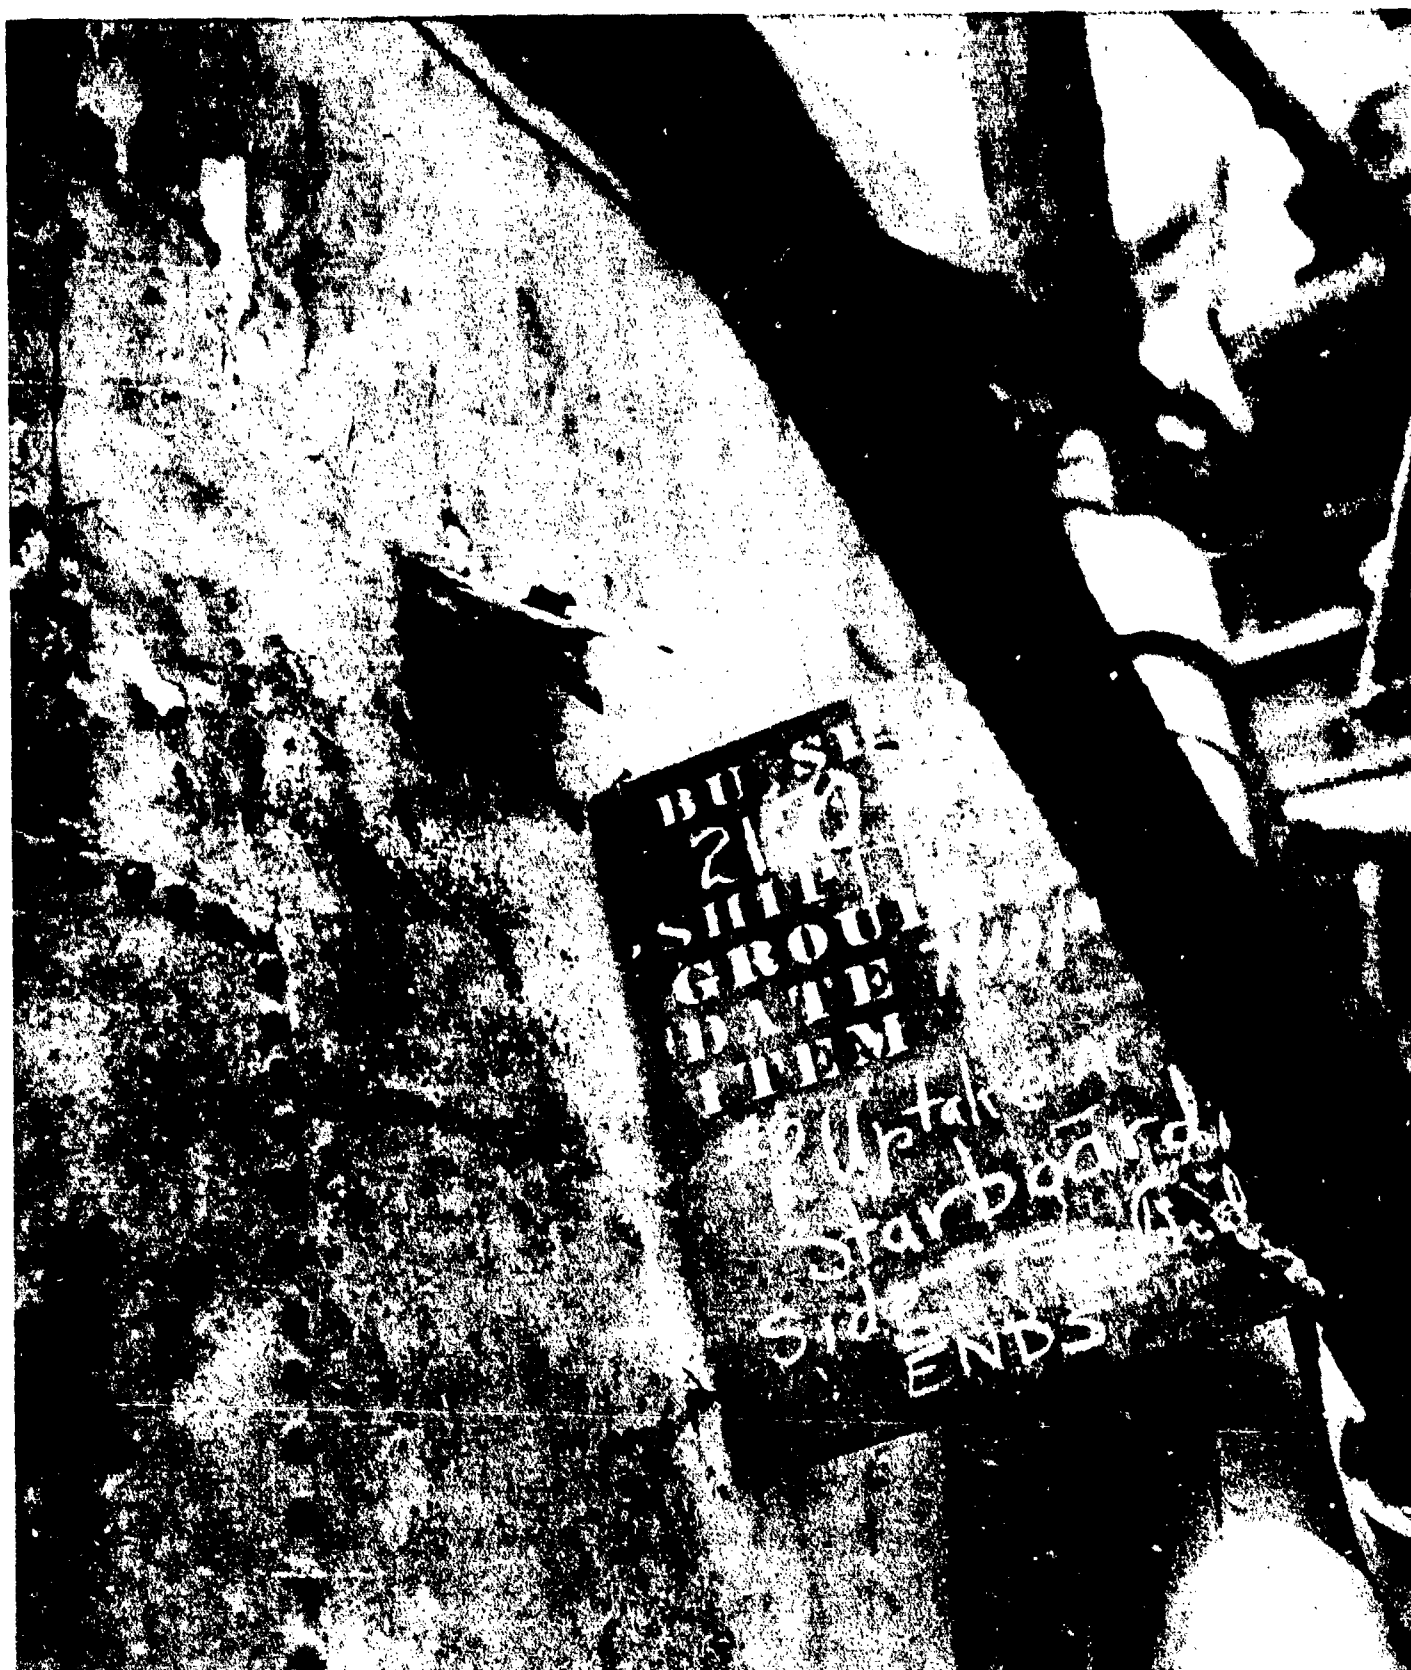
AA-CR-62-2170-4. No. 2 uptake, starboard side.
